TOWN OF MAYNARD

FACADE IMPROVEMENT PROGRAM

I · N · V · E · N · T · O · R · Y

Lane, Frenchman and Associates, Inc.

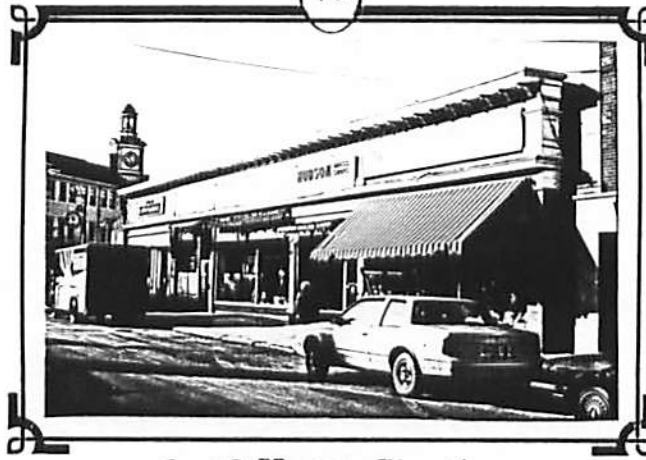
93-115 Main Street, 2 Nason Street

Built in the mid 1920's, this large commercial block was quite typical of row retail structures that subdivided space for several tenants into deep, narrow shops. Often referred to as "taxpayer properties" these buildings were constructed inexpensively as a temporary means to pay off property taxes until the owner could build a larger structure. Luckily for Maynard, this structure was never to be demolished, for it was built with an unusually high level of stone detailing. Although replacement aluminum storefronts obscure this detail with garrish colors and oversized signage, much of the original ornament remains with need of little repair. The stone piers dividing each storefront still exist and are capped along the cornice line with elegant oval shaped medallions. Originally, terra cotta finials dotted the length of the cornice in line with the piers; unfortunately they were removed sometime after 1930.

The unfortunate replacement of original wood storefronts with the current flat aluminum infill panels dates from around the 1960's. The large, brightly colored signage is sized to be read from a highway, not from Maynard's Main Street. Most distressing is the overscaled, wood fascia which was added to the front of the Copper Kettle; thankfully this "billboard" sits in front of the original wall which remains virtually undamaged behind it.

Recommendations Remove all existing signage, including the Copper Kettle "billboard", and replace with signs fit into the uppermost panel of the storefront. These signs should not protrude or cover the stone piers or cornice. In addition, small scale projecting signs would be warranted.

- The stone work should be patched and repaired as necessary, and painted with proper paint in a neutral color that attempts to match the natural stone color.
- A proper restoration of this building would include replacement of existing storefronts with a well detailed system that fits the architectural frame. As this would be a costly undertaking, the owner should at least "retrofit" the existing aluminum system with neutral colored replacement panels for the bright red and blue opaque clerestory and base panels.
- Awnings should be replaced.

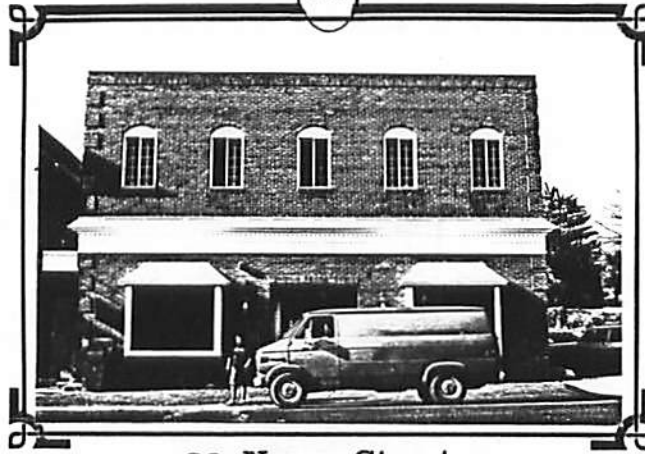
34 Nason Street
The Outdoor Store

The upper floor of this two-story wood frame building retains much of its original 1910's wood detail, but its storefront likely was renovated in the 1940's. It is unfortunate that the renovation replaced the wood storefront cornice with porcelain panels. More recent renovation has left half of this band covered with wood siding. Happily, the original wood trim around windows and at the upper cornice remains and the upper floor retains its clapboard. Its lively rose color is handsome along the street and the lemony white color of window and cornice trim draw attention to that detail.

Recommendations Restore the storefront cornice to an appropriate wood cornice, and incorporate new long, narrow wood signs above each storefront.

- Restore the storefront base with wood detail to cover the contrasting brick base.
- Paint the rear facade, as it will be quite visible from the improved municipal parking lot. Improvements to the rear parking lot may warrant providing an entry and canopy off the rear facade.

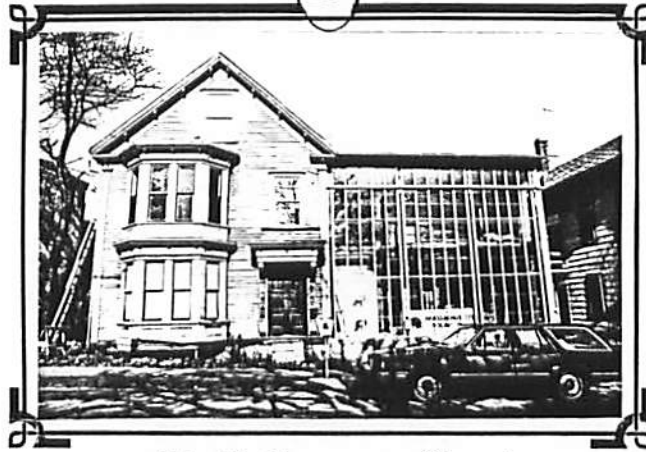
63 Nason Street, 37 Summer Street
Masciarelli Jewellery/Style Unlimited

A fire sometime in the middle of this century destroyed the upper mansard floor and it was not rebuilt. The clapboard on the middle floor was replaced with the cementitious stucco that now exists and the windows were replaced with smaller "sliders". At the base, the original slender-columned, wood frame porch was replaced by a shed roof and new aluminum storefront.

Recommendations A new facade treatment seems necessary as the upper floor stucco work appears cracked and stained. If replaced, wood clapboard should be used. The bland aluminum flashing at the building's top should be replaced with a wood cornice if the facade is restored. Also, shutters might be replaced around upper floor windows.

- Existing windows are smaller in size and of a different type than the original 2 over 2 double-hung windows. If replacement is warranted, larger, double-hung windows should be used.
- The shed roof should be removed or redesigned to resemble the "porch" with the additions of columns.
- Signage should be removed from the edge of the shed roof and replaced by appropriately sized wall mounted signs.

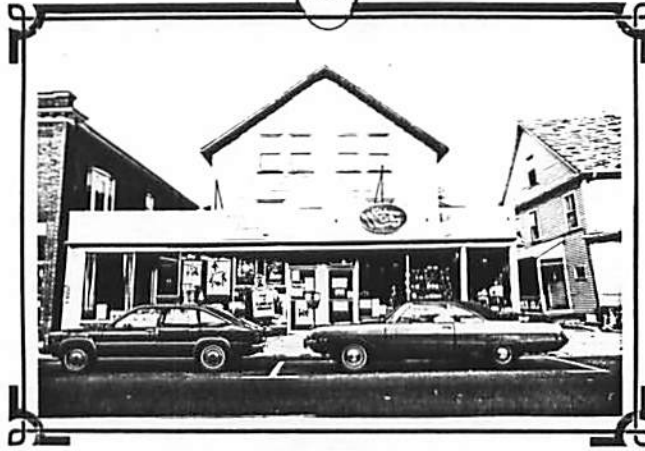
35-37 Main Street

Although in need of some serious repairs, this structure retains the original business storefront with most of its original woodwork and detail. It is likely that the shop was built in the 1920's. Through the years the glazing and wood base of its storefront have been altered.

The storefront remains of an appropriate plan and design; a central entry door connects to the house at the rear and divides two shop fronts of equal width. The brown paint color is too dark and awnings have not been kept in shape. The small, projecting sign of Atlantis Jewelers is appropriately scaled; signage for K&J Taxi should be similarly noted.

Recommendations The degree to which the facade leans may indicate structural damage. This should be checked before any work is done.

- Scrape, prime, and repaint all existing clapboard and wood trim on rear house and on storefront.
- Gutters and downspouts on rear house must be repaired or replaced.
- Rehabilitate or rebuild the storefront in a manner consistent with its original image. Repair the trim on the cornice, replace awnings and repaint in a lighter color palette. If the storefront glazing is replaced, an insulated glazing should be used and a framework for clerestory glazing should be added.
- Signage should be placed above each door on the cornice, and a small, projecting sign should be added for the Taxi Service.
