TOWN OF MAYNARD

FACADE IMPROVEMENT PROGRAM

I · N · V · E · N · T · O · R · Y

Lane, Frenchman and Associates, Inc.

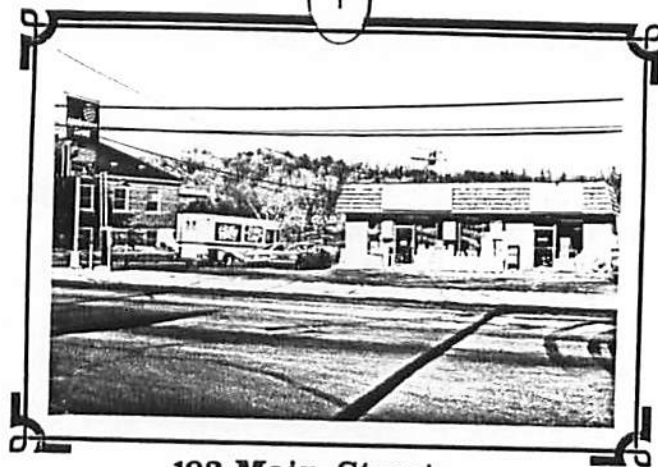
193 Main Street

It is unfortunate that "highway strip" buildings, such as this structure, have been placed along Main Street. The fact that these buildings sit back from the sidewalk, maintain broad curb cuts along the street, and profile cars parked to their front destroys the historic Main Street imagery. The oversized freestanding signs cater to people driving by in cars, rather than to pedestrians. It is particularly unfortunate that the sign blocks the view of the Town Building.

Recommendations Landscaping improvements should be made to reduce the overly wide curb cut to a simple "in" and "out". A low planting buffer should be placed along the sidewalk; a low hedgerow would not obliterate a view of the store, but rather, enhance one's view of the Town Building.

- The freestanding sign should be replaced with a smaller scale sign at the middle of the property (incorporated into the landscaping) rather than at the corner.
- If this structure is ever renovated, its facade should be made to look more "village" like, by providing a simple gable front and a white clapboard facade.

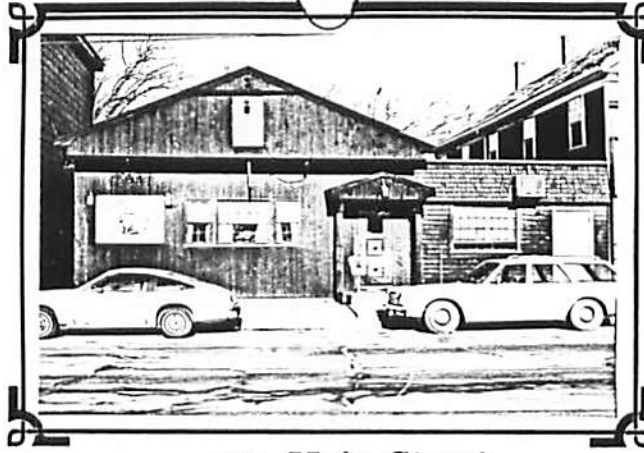
163 Main Street
Sit'n Bull Restaurant

This small building retains little of its original house imagery. The addition of vertical siding & shingles, painted dark brown, creates a somber appearance. The small windows allow few views into the restaurant while the solid wall does not allow activity along the street.

Recommendations Renovation of this structure should strive to combine the two disparate pieces of the facade. At the base, a continuous porchfront treatment similar to that of the Quarterdeck Restaurant (Property 5) will allow smaller windows to fit into a separate frame.

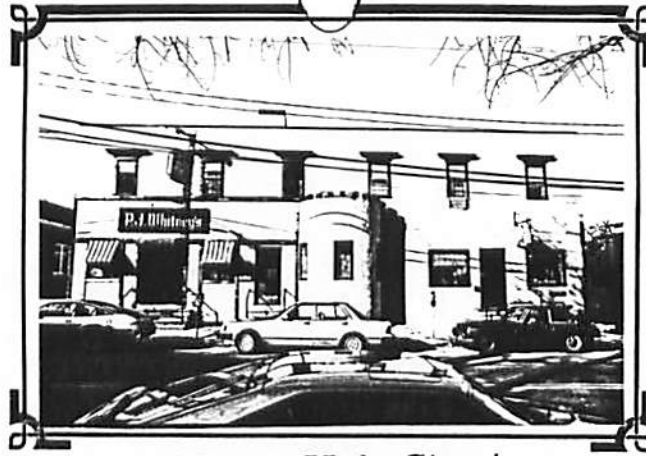
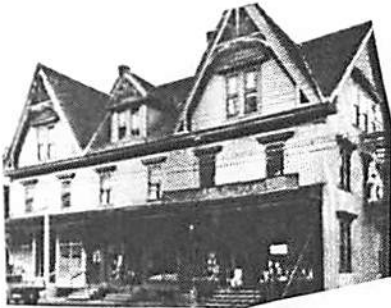
133-135 Main Street

Originally known as the Amory Block, this structure was likely built around 1880 in the Stick Style. It originally had a steep roof with several gable ends that featured exposed framing. A projecting eave above the storefront was supported by large brackets; horizontal clapboards and shingles covered the facade. Steps up from the street had simple, cast iron pipe railings.

At some point the uppermost story of the structure was removed and a flat roof was added; at that time, the storefront glazing was also removed. Recent renovation has changed the building's image even more: the clapboards have been replaced by a textured stucco, the storefronts have been reduced to large window openings in a heavy wall, and a medieval topped bay has been added. The half timbered facade of the restaurant is an unfortunate stylistic choice. All that remains of the original facade are the ornamental window heads.

Recommendations The stucco was an unfortunate choice for siding -- if at all possible, it should be returned to clapboard. If renovation is undertaken, it should replace a roof similar to the original.

- If the siding is not replaced, wall mounted signs for the Newstand and Eye Group should be added above the windows.
- The gold color which the facade is currently painted is too dark. When repainted, a lighter peach or off-white should be used. (See color chart).

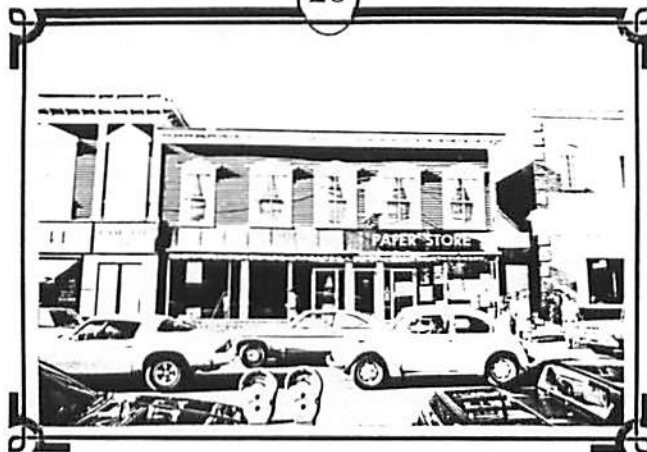
34 Nason Street
The Outdoor Store

The upper floor of this two-story wood frame building retains much of its original 1910's wood detail, but its storefront likely was renovated in the 1940's. It is unfortunate that the renovation replaced the wood storefront cornice with porcelain panels. More recent renovation has left half of this band covered with wood siding. Happily, the original wood trim around windows and at the upper cornice remains and the upper floor retains its clapboard. Its lively rose color is handsome along the street and the lemony white color of window and cornice trim draw attention to that detail.

Recommendations Restore the storefront cornice to an appropriate wood cornice, and incorporate new long, narrow wood signs above each storefront.

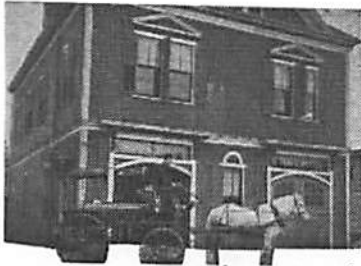
36 Nason Street

The rear portion of this building was constructed in 1892 as Maynard's First Fire Station. Changes in ownership through the years had altered the original structure considerably by 1980. Just last year, the Town Paint and Hardware building underwent its most complete facade change. A new brick veneer building was built at this site. The brick facade which is now presented to the street attempts to look like the type of large brick buildings that were built along Main Street in the early 1900's. The building does a good job of fitting this structure into the townscape: it maintains a similar height to its neighbors, provides appropriate scaled upper floor window openings, and places a typical wood cornice over the storefront. It is unfortunate, on the other hand that the building does not have a bracketed roof cornice (rather it has a flat brick band) and that it does not maintain a typical open storefront (rather it has two large bay windows punched into a masonry wall at the base). The owners of this building should be commended for having extended the same level of detail on all sides of the building, particularly on the rear facade which will face the improved municipal lot. It is a shame that to do so, the original "town lock-up" which was at the rear of the building had to be destroyed.

Recommendations Signage, if it has not been considered, is necessary on the front and rear of the building. On the front, a long narrow sign should be fit above the door.

- A wood top cornice would be appropriate.

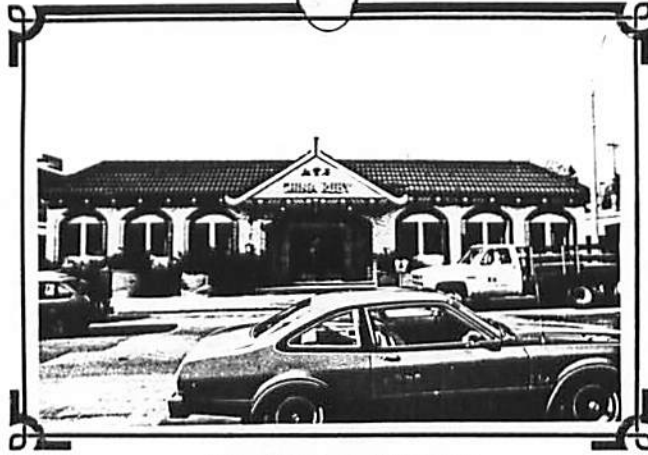
42 Nason Street
China Ruby Restaurant

Once the site of the Odd Fellows Block, a tall three-story, wood frame building with an elegant storefront, this site is now home of the China Ruby restaurant. The building's style, color, and signage are meant to evoke Chinese imagery; it is a building that is "decorated" to express a time and place that have nothing to do with Maynard. Although the restaurant makes an important contribution to the business community, this type of image should not be duplicated elsewhere in town. Singularly, it is a contrast to the typical townscape, but if several merchants attempted to make their buildings "look" like their product, the district's village flavor would be lost.

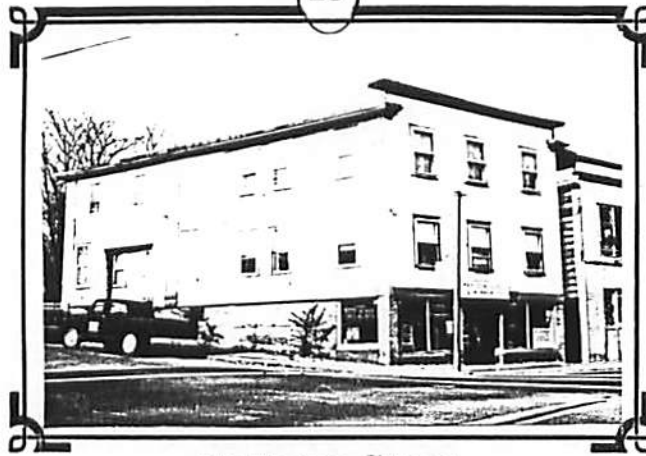
60 Nason Street

This building occupies the site of Grove's Bakery which was built by 1880. The rear portion of the building is the original Grove's Bakery building; the front portion, built at a later date, is an addition to the original structure. The original Grove's Bakery was a wood frame structure sheathed in wood clapboard with a simple, bracketed wood cornice. The slope of the Summer Street hill allowed the insertion of a floor under the original first floor; this is now the level of the retail shops. Alterations to the original building and its addition have included stuccoing, window replacement, removal of original window trim, and destruction of the wood cornice.

Recommendations Rehabilitation should focus on securing the building envelope. The cementitious stucco work, which is stained and cracked, should be removed and replaced by wood clapboard. If it is necessary that windows be replaced, their opening size should not be altered; replacement windows should be 2 over 2 double-hung frames. Wood window trim should be replaced as necessary. The cornice should be repaired and repainted; in no case should the wide soffit be altered. The wood storefront should be repaired and repainted.

- The entry to the upper floor apartments off of Summer Street should be appropriately detailed, possibly with a pediment placed over the wide opening.
- The handsome brick base and storefront piers should be retained and repointed as necessary.
- New signage should be provided, tied into the storefront lintel.

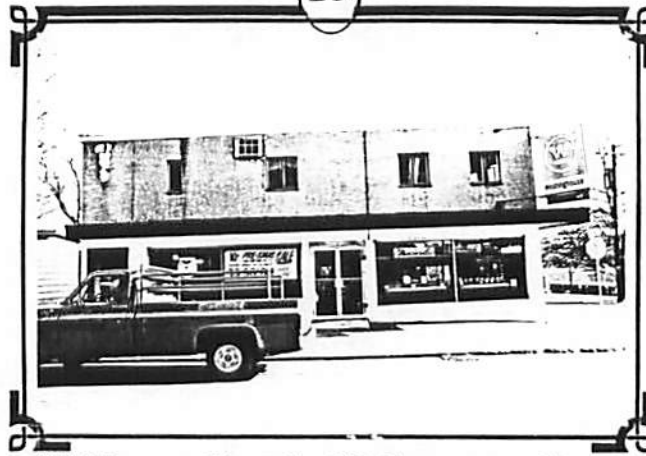
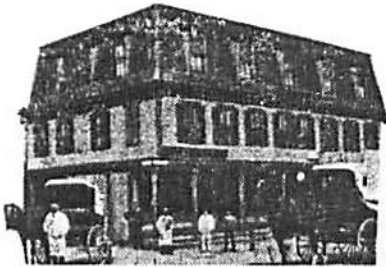
63 Nason Street, 37 Summer Street
Masciarelli Jewellery/Style Unlimited

Built on this corner site in the 1870's, this building once presented a three-story facade to the street (the upper most floor was a tall mansard roof). Known originally as "Darling's Block", for many years it housed a meat market, a barber shop, and a pool room; the Riverside Corporate Association started business in the basement in 1875. Sometime after the First World War the building was acquired by the Fraternal Order of Eagles, one of the oldest lodges in Maynard.

A fire sometime in the middle of this century destroyed the upper mansard floor and it was not rebuilt. The clapboard on the middle floor was replaced with the cementitious stucco that now exists and the windows were replaced with smaller "sliders". At the base, the original slender-columned, wood frame porch was replaced by a shed roof and new aluminum storefront.

Recommendations A new facade treatment seems necessary as the upper floor stucco work appears cracked and stained. If replaced, wood clapboard should be used. The bland aluminum flashing at the building's top should be replaced with a wood cornice if the facade is restored. Also, shutters might be replaced around upper floor windows.

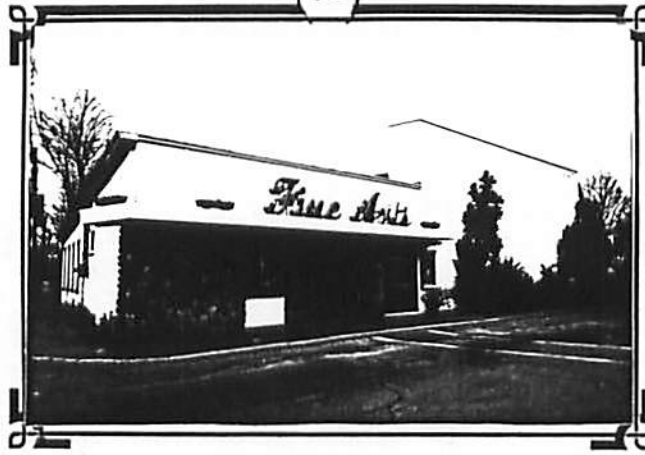
A modern use inserted amidst traditional houses, the Fine Arts Theatre contrasts the surrounding. Heavily planting obscures the bland white walls of the theatre. The illuminated sign draws just enough attention; the marquis is quite simple and signs for coming attractions remain small.

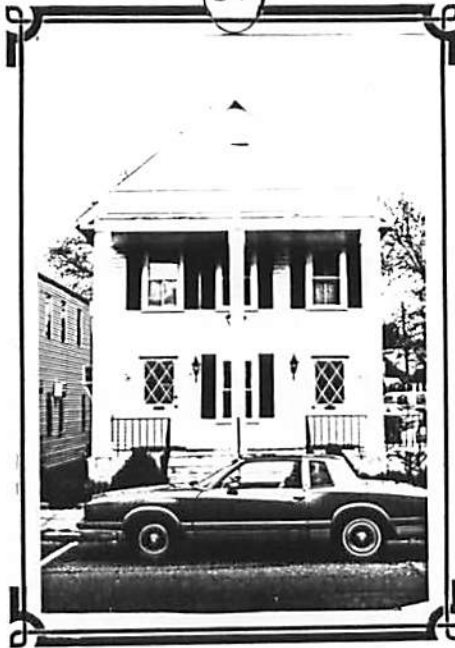
25 Main Street

Constructed as a house, this wood-frame building has undergone renovation to function as an office on its ground floor. The two-story porch front which has been added is meant to evoke a "colonial" imagery"; as such, it seems out of character with neighboring structures that have a single story porch front. It is unfortunate that this building was altered so extremely from its original house imagery.

Recommendations If, at some point, the owners choose to renovate and again change the image of their building, a front should be styled to mimic the original single story porch, the aluminum siding be replaced with wood clapboard and the top "gingerbread" shingles should be preserved.

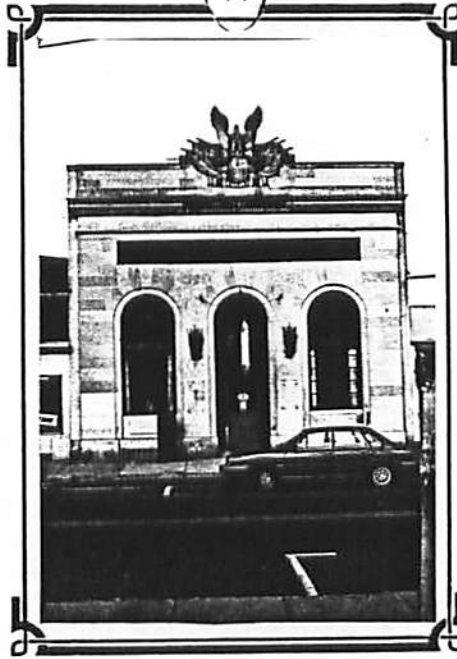
81 Main Street

Recommendations Slight staining has occurred on the stone cornice; it is likely that the entire facade should be cleaned with a mild wash.

- The sign band, now blank, should be filled with a sign for the current owner which is similar to the original sign. The projecting sign should be removed.
- The door, while not original, is acceptable. Its color should match that of the windows.

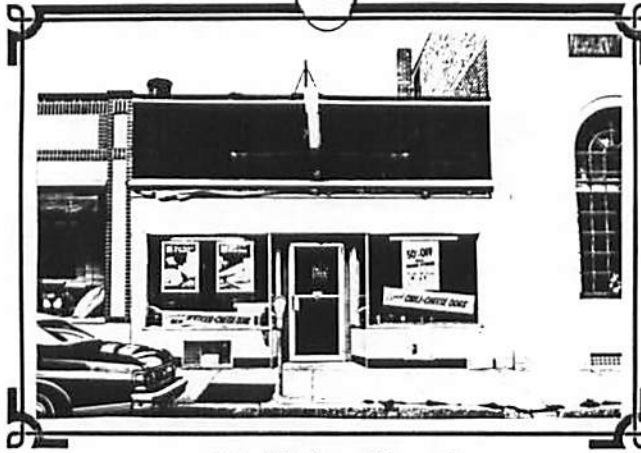
83 Main Street
The Taco Maker

This single story structure was built as a simple infill between its neighbors sometime in the mid-century. Although it is unlikely that this building had remarkable original detail, it is unknown if the existing plain storefront is original. The addition of the false shed roof in recent years is inappropriate and should be removed.

Recommendations Removal of the false shed roof is a high priority. A new flat upper facade should pick up the lines of the adjacent structure (Property 43).

- The oversized projecting sign should be removed and new wall-mounted signage should be incorporated into a new treatment of the cornice.
- The porcelain coated base panels should be repaired as necessary.

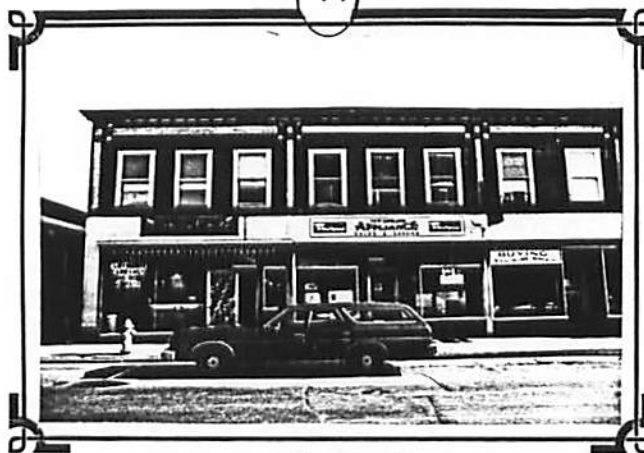
15,13,11 Nason Street

Recommendations Rehabilitate base of building by removing siding.

If individual storefronts are altered new window bases should be built with a facing material similar to the brick or stonework above, or in wood.

- All woodwork, including the cornice and the upper floor window trim should be scraped, primed and painted.
- If the building base is rehabilitated, new signs should be made to fit within the architectural detail.
- The rear elevation, now a prominent view from the municipal parking lot, should be improved.
- Improvements to the municipal parking lot have drawn attention to the building's rear facade; thus, it is important that the rear facade be improved as part of the upgrade to the entire business district image. To do so will require the effort to re-clapboarding the upper floor, improving the fire stair, shielding the dumpster, and repainting.

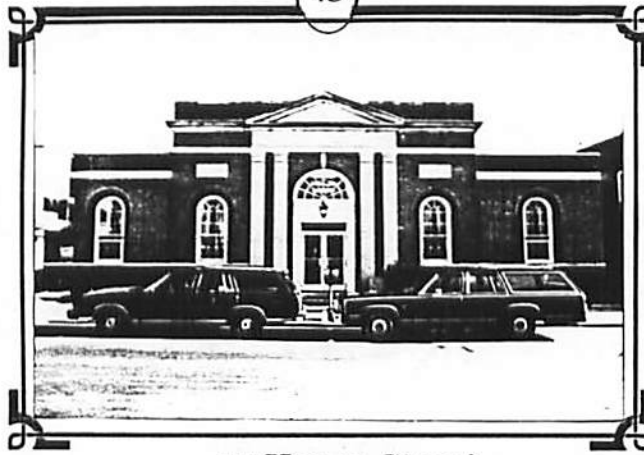
17 Nason Street

Items to Preserve All existing facade features.

Recommendations No changes are suggested for the structure; it should remain, unaltered as a building of substance in the business district.

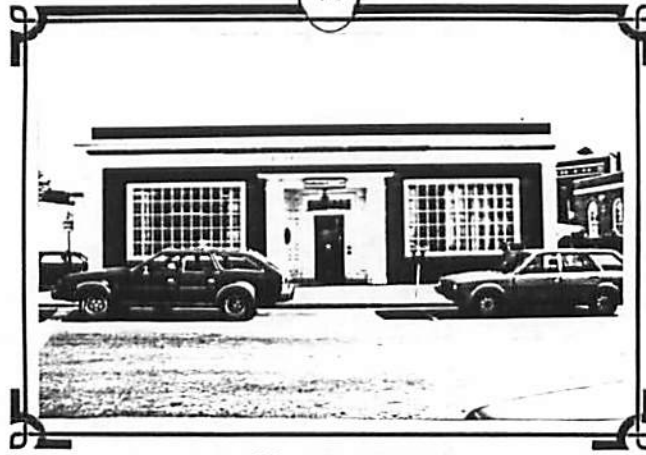
25 Nason Street
Baybank Middlesex

Baybank Middlesex has occupied this site since 1965 when it expanded and took over the building from First National Stores. Renovation of the front facade incorporated a wood cornice, pilasters, and recessed entry. Multi-paned windows fill openings in the masonry wall. Baybank Middlesex is one of the few businesses that has incorporated an entry at the rear building facade. This small, white wood entry pavilion adds a liveliness to the municipal lot.

Recommendations The blank half of the rear facade should be incorporated into design of the entry pavilion.

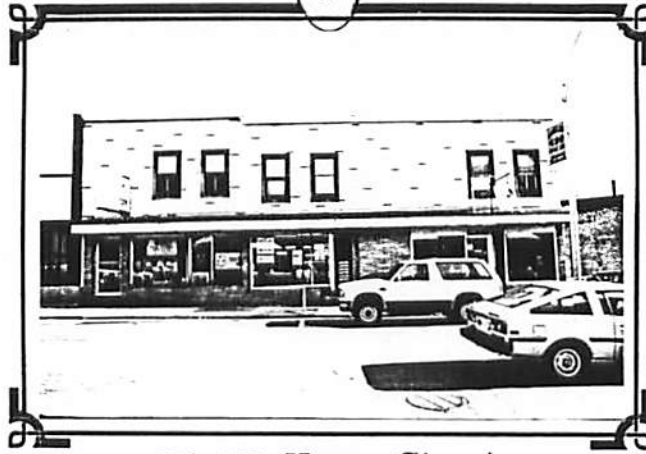
37 ,33 Nason Street

Recommendations Front Facade: The contrast in materials between the top and the base of this building is not in keeping with traditional brick multi-story building in Maynard. The brick patterns and gold color are also a contrast to the red brick used on other similar buildings. Residing this building in wood clapboard would improve its appearance immensely; if such redesign is untaken, the two separate structures should again be expressed. Window and cornice trim should be of wood and the storefront base should be consistent with the upper story wood treatment.

- The shed roof above the storefront should be removed and replaced with a traditional storefront signband. The canvas awnings which characterize Maynard should replace the overhang.
- Projecting signs should be removed and replaced by long, narrow wall mounted signs (as the overhang is replaced) and small projecting signs.

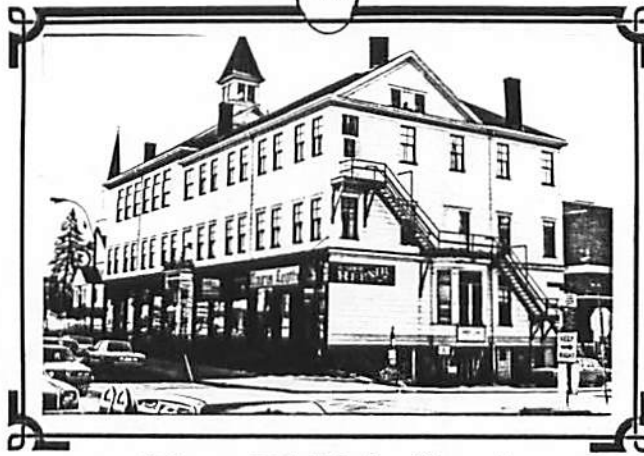
94a - 104 Main Street

Very little change has been wrought upon the wood frame structure since its initial construction. The original roof and cupola remain as do the original "stoops" and entryways. Although both upper floor and storefront windows have been replaced at various times, the replacements have retained the proportion and size of original window openings. The most unfortunate change has been the replacement of the original clapboard siding with a wider particle board siding. Also, when the building was resided, the vertical horizontal trim boards which divided the upper floors were not replaced.

Recommendations Because the building faces North and does not get direct sunlight, the brown color of the base is too dark. It should be repainted in a lighter color palette, possibly with two tones to bring out detail on the columns.

- When the building is resided, clapboard should be used, and the original vertical and horizontal trim should be replaced.
- Downspouts should be repaired.
- The oversized "Taurus Leather" wall mounted sign should be removed and replaced by hand painted signs on the clerestory glass of the storefront, as the adjacent storefront demonstrates. All signage should be done this way; small projecting signs, similar to the projecting "Taurus Leather" sign may also be used.

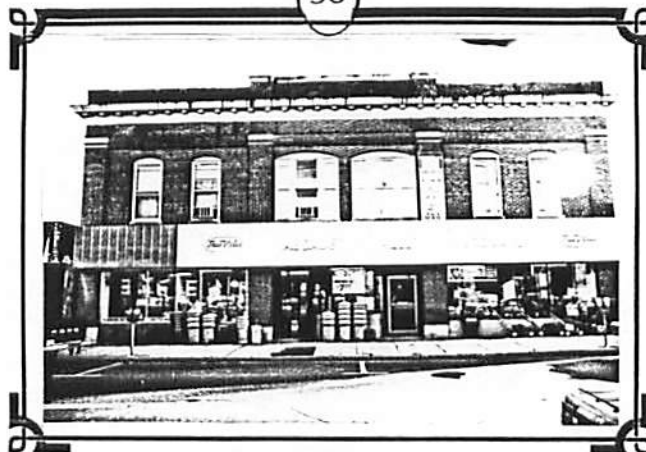
74 - 76 Main Street

An artist's rendering depicts the storefront as it was originally built in the 1910's. Narrow white wood bands framed glass openings between piers, but did not stretch across them. Unfortunately, the simplicity of the original storefront has been destroyed by the addition of the heavy horizontal wood band which now separates the elegant upper story from the base. The overly bold signage band cuts the piers in half, destroying the vertical quality they were meant to lend to facade. The original storefront glass also has been replaced.

Recommendations Restoration of the facade should be made a priority. This should include removal of the wood signband and replacement of simple signage bands, between brick piers (never across the piers), to cap the storefront glass. These bands should be no taller than 18 inches. Removal of the signband may require cleaning and repainting of the masonry which exists beneath it.

- The directory which is mounted to the pier at the second floor should be removed and replaced by a directory at the entry

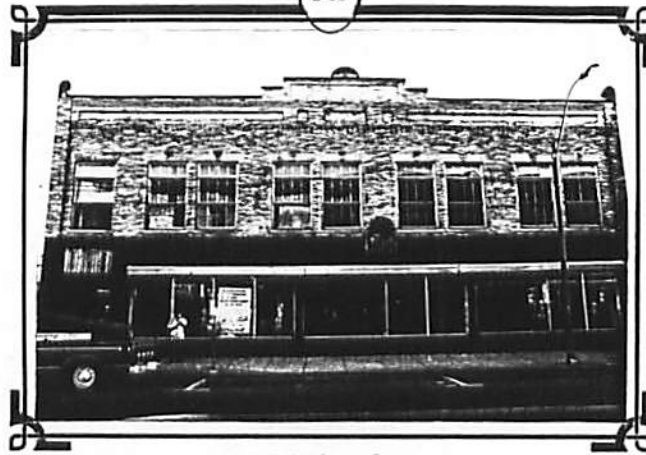
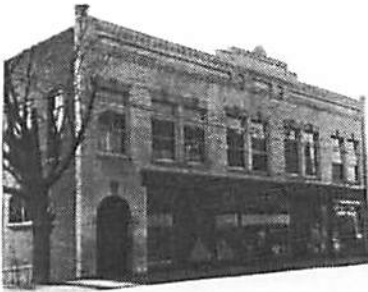
56 Main Street

Built around 1910, the Cannon's Block maintains a handsome buff colored brick facade on its upper floors but has been severely altered at its base. The handsome brick cornice, stepped to the middle, displays the restrained brick ornamentation that was popular when this structure was built. The playful, scrollwork finials to each end and the semicircular panel at the middle, enliven the top. There is a curious asymmetry about the placement of the window openings; although the cornice is symmetrical about its center, the paired windows do not center about the same point. The multi-panel windows, while not original, do mimic the three horizontal lines of the originals. Handsome stone lintels with keystones frame the top of the windows.

At one time an archway at the ground floor served as the primary entry to the floor above. It is likely that this has been destroyed. The original storefronts were long ago replaced.

Recommendations Restore the ground floor in a similar manner to its original construction. Replace (or restore if it exists) the arched masonry panel at door to main building (to left side). Replace the storefront lintel at the same height as the original. Replace the storefront glazing to match the original.

- Clean upper floor masonry.
- If storm windows are added, they should be placed on the inside.

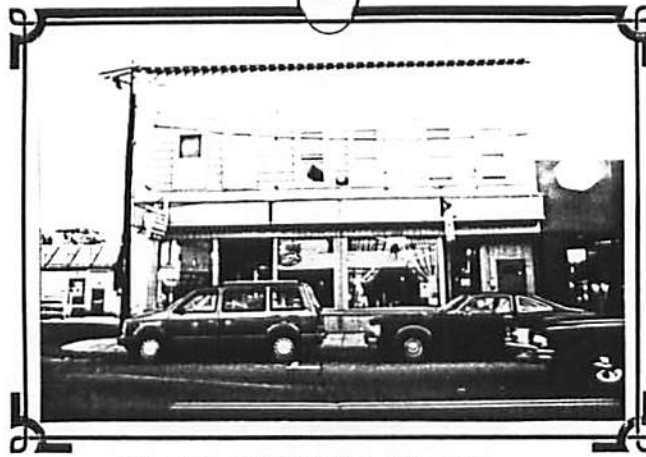
40, 42, 44 Main Street

It is unfortunate that when this structure was remodeled, much of its original detail was lost and/or covered. The original clapboard was replaced with wide strips of particle board siding. Siding also has been boxed around the original storefront cornice line; it is likely that a handsome signband exists below this siding.

Recommendations Restoration of the original wood trim should be a priority for this structure. Removal of the siding above the storefront will reveal if the original cornice exists below. If it does, it should be restored and repainted; if it does not, it should be replaced.

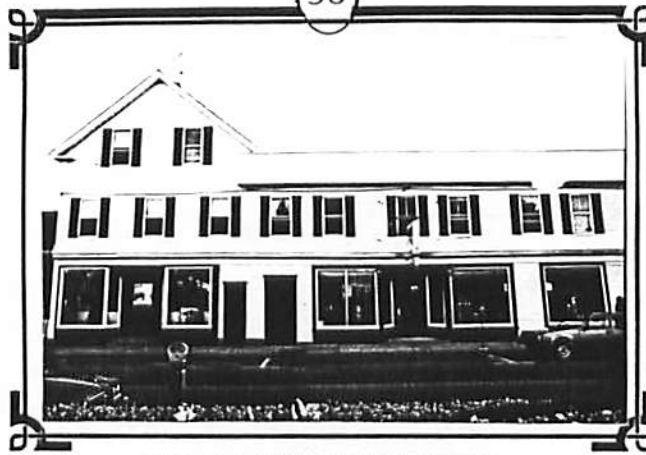
32, 34, 36 Main Street

Although this wood frame building has gone through many changes, its well maintained, white facade is a handsome addition to the streetscape. Its storefront windows retain their original openings and wood bases and trim. Shutters on upper floor windows enliven the facade. It is unfortunate that aluminum siding has replaced the original clapboard and boxed out the cornice line of the two-story block.

Recommendations It is likely that much original wood trim exists below the aluminum siding. This can be checked by lifting certain sections of the siding. If it is determined that detail does exist, the siding should be removed and the original woodwork should be restored.

- In any case, the boxed portion of the cornice which is heavy and awkward on the two-story block should be removed and replaced by a more simple eave and bracket.
- If storefront glazing is replaced, it should incorporate a clerestory light at each storefront.
- Awnings might be added.

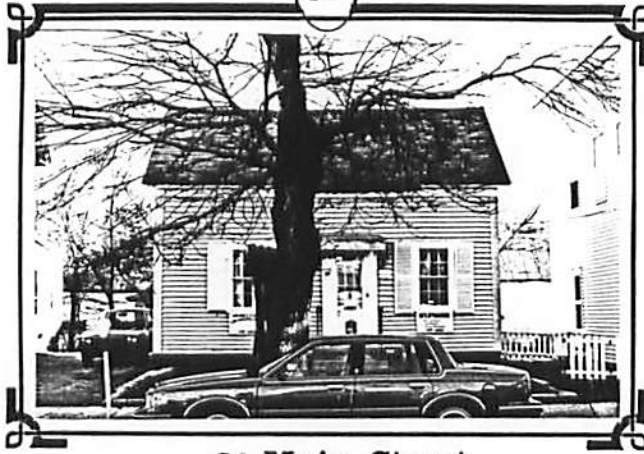
30 Main Street

This small house has been restored with care. Its lively rose color and simple door and shutters provide it with a traditional look.

Recommendations Plant grass and/or flowers in the front yard.

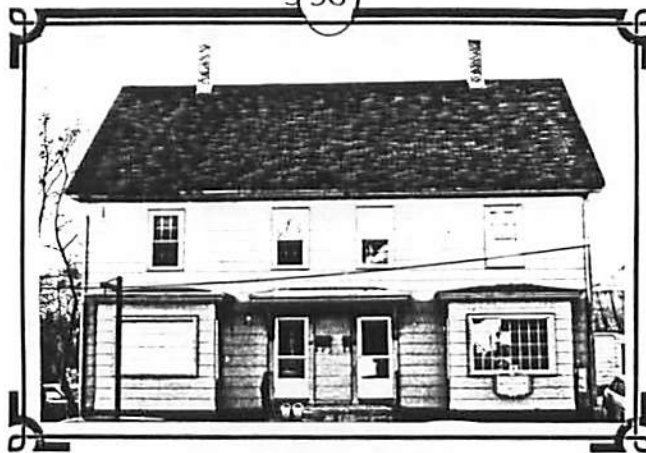
26, 28 Main Street
Columbo's Barber Shop

Just one half of this duplex is used for business purposes; the Barber Shop is unobtrusive on the facade and should remain so. It is unfortunate that when the building was resided, much of its original wood detail was destroyed.

Recommendations The building, if resided, should use clapboard. In any case, the structure should be painted in a lighter, whitish color.

- The canopy over the door should be highlighted in a contrasting color.

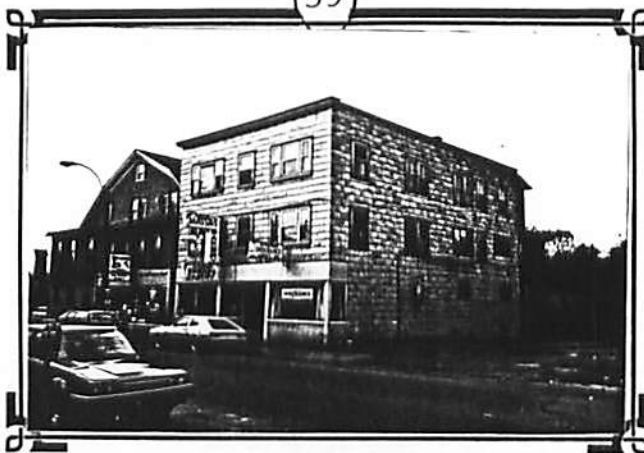
20, 16 Main Street

Renovation of the structure years ago destroyed much original detail. Neither the particle board siding or its color have aged well and should be replaced. Aluminum storefront panels and the brick base lack interest as well. On the other hand, the symmetry of the facade and the wide, three-part windows are elegant.

Recommendations Reside building with clapboard.

- The storefront should be redesigned with wood detail, to match similar historic storefronts of this building type (as example, Property 38).
- Remove oversized signage and provide new signage at the signband.

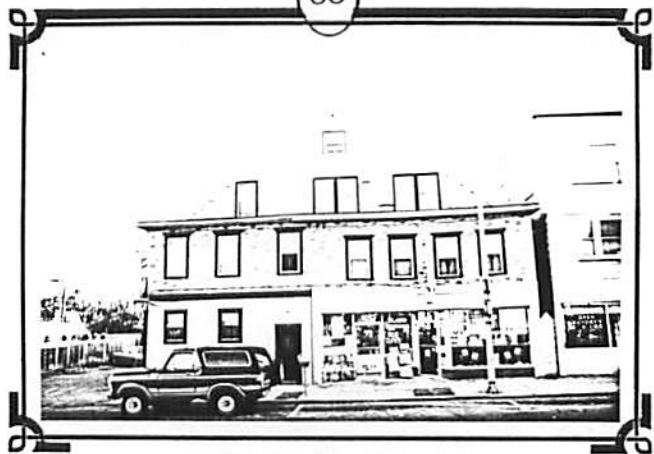
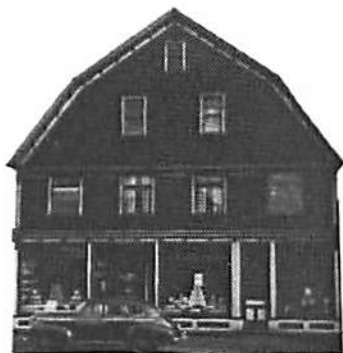
12, 14 Main Street

The original, wood frame market has been greatly altered through the years. The building once sat back from the road until the two-story "porch" front was added. It is likely that this addition was added in two stages, because the windows are not in a level line across the second story. The choice of asphalt siding for the building was poor.

Recommendations Reside the building with clapboard.

- Redesign the storefront sections so that there is a consistent line across the base. The storefront should match similar historic storefronts for this building type (as example, Property 38).
- Provide new signage incorporated into the new storefronts.
- Provide an improved entry to the upper floors with a covering over the main entry door.

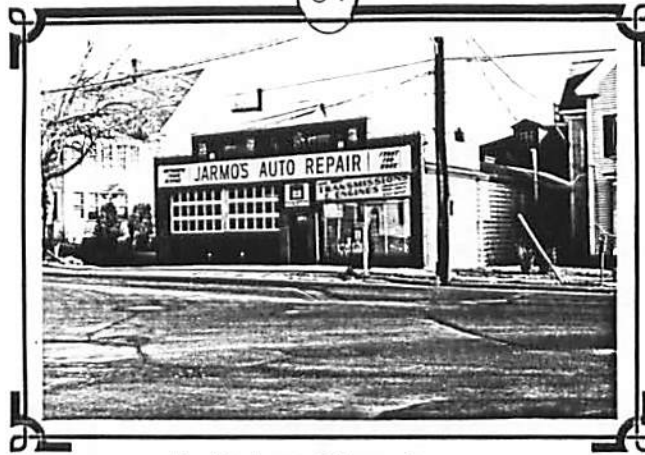
5 Acton Street
Jarmo's Auto Repair

Built to serve as a commercial garage, this structure has a playful masonry facade. Unfortunately, oversized signs hide its detail.

Recommendations Remove all signage and provide a single wall mounted sign to fit into the architectural frame.

- Paint existing garage doors and pedestrian doors in the same color, using either a salmon or ivy color.

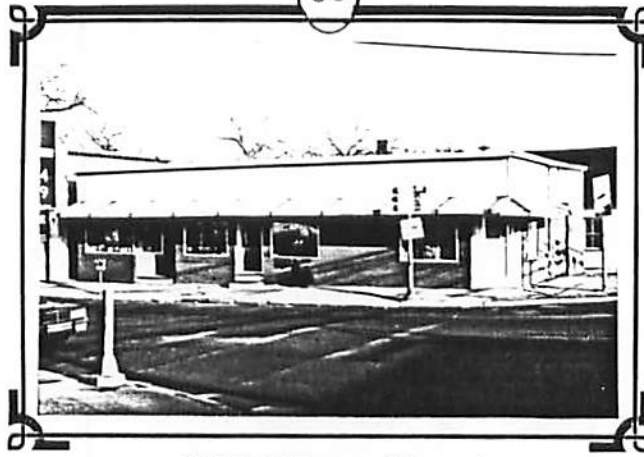
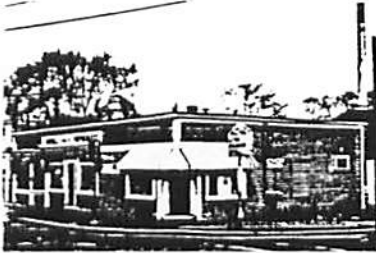
8 Waltham Street

Renovation of this building sometime in the late 1960's removed the original clapboard siding and replaced it with a simulated brick base and aluminum siding. In fact, the original wood detail was quite charming and it is unfortunate that it was removed. The current aluminum awning is not as nice a canopy as other canvas awnings throughout downtown.

Recommendations The one-story height is rather low to mark this major intersection. If the facade is redesigned, it should include a vertical emphasis at the corner.

- The awning should be replaced with a canvas awning.
- If, at some point, the owners choose to renovate the facade, replace plastic brick siding with wood clapboard.
- Add signage above awning or project appropriately sized sign at corner.

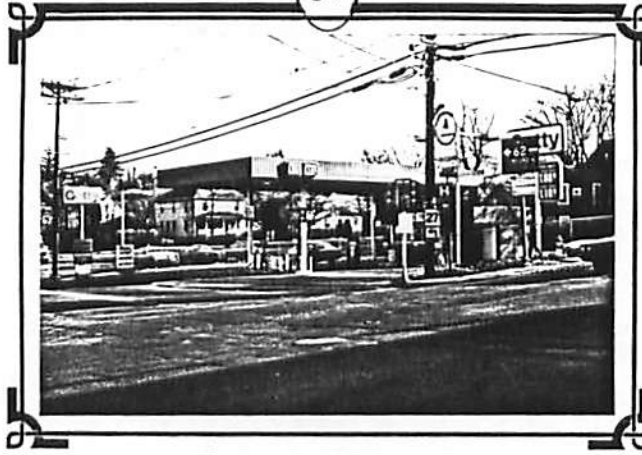
Waltham Street
Gas Station

Set back from the intersection, this gas station occupies a prominent corner site.

Recommendations Provide plantings along the street edge, and reduce curb cuts.

- Provide a landscaping and a white picket fence along the Waltham Street edge.
- It would be wonderful if this station chose to remodel its canopy and building to reflect the image of a town rather than a highway strip.

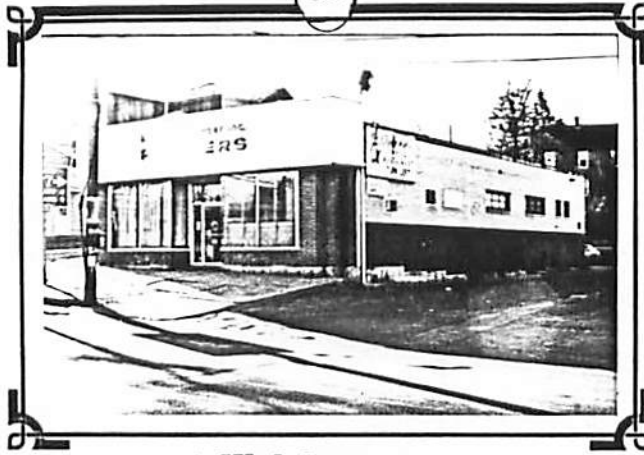
7 Waltham Street
Murphy and Snyder Printers

This one-story facade has a simple brick base and a heavy cornice/signband sheathed in aluminum. The signband is too deep for the base.

Recommendations The signband should be better designed to "fit" the base. Its corners should step back as do those of the brick base. It should have a detailed top and bottom, incorporating signage between vertical lines.

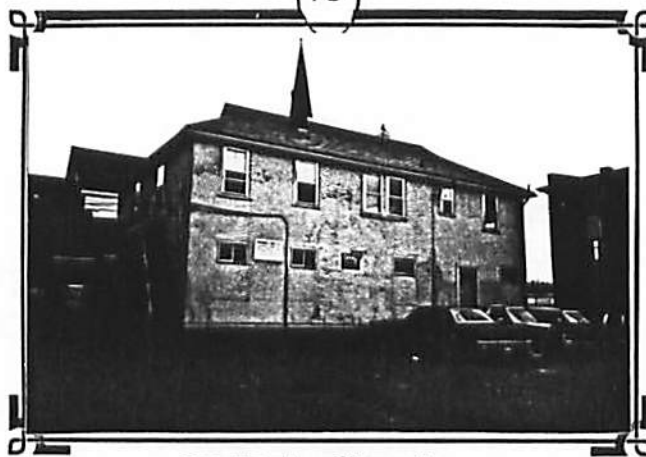
80 Main Street

Vacant

Recommendations Improve facade with light colored clapboard.

- Provide landscaping along River Street.

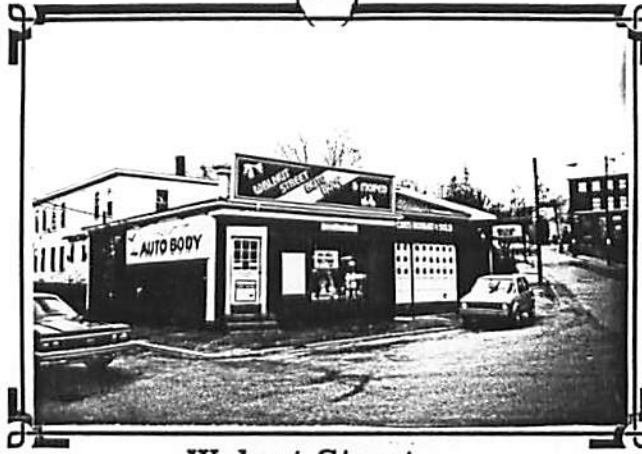
Walnut Street Auto Body

Recommendations Paint garage doors white.

- Provide small scale signs fit to architectural frame.
- Clean up rear yard and provide low, picket fence along street.
